# Recall System & Latest Issue in Korea

(Defect investigation on panoramic sunroof)

March 2014

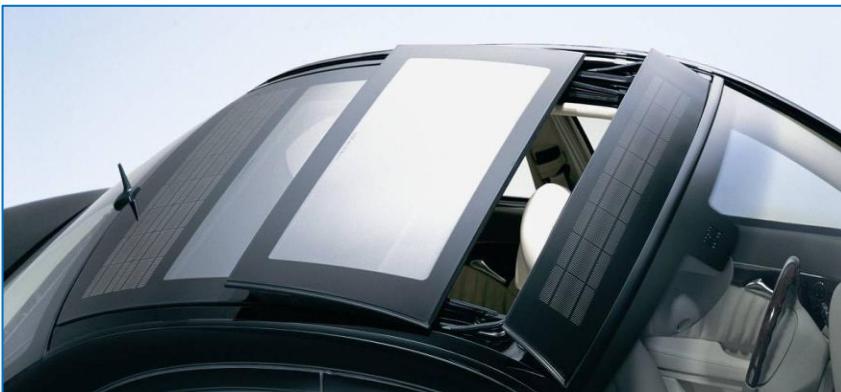
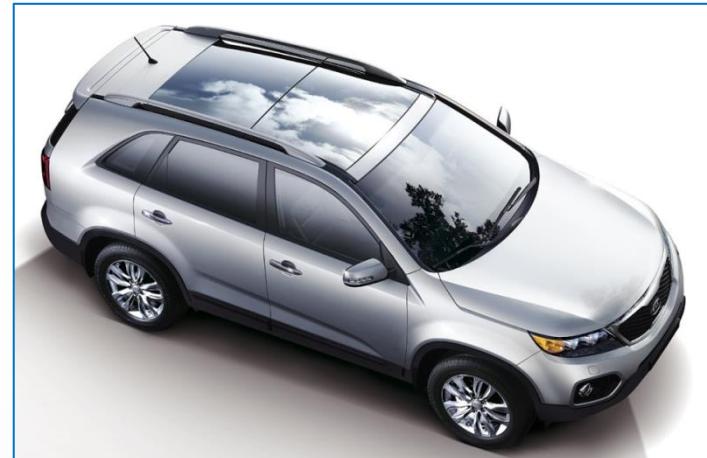
- Sharp increase in consumer complaints of panoramic sunroof
  - 2011: 2 cases
  - 2013: 33 cases (5 cases of imported models)
- Details of consumer complaints
  - Sudden shattering of panoramic sunroof while driving the car with the driver unaware
  - Driver may suffer abrasions due to shattered glass and encounter risk of secondary accidents

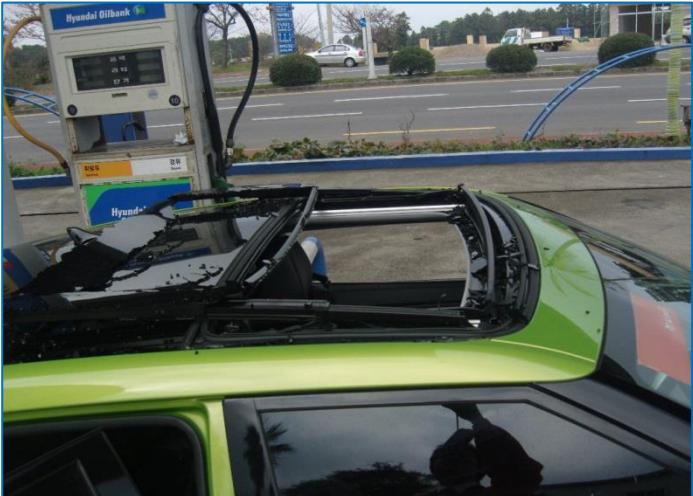
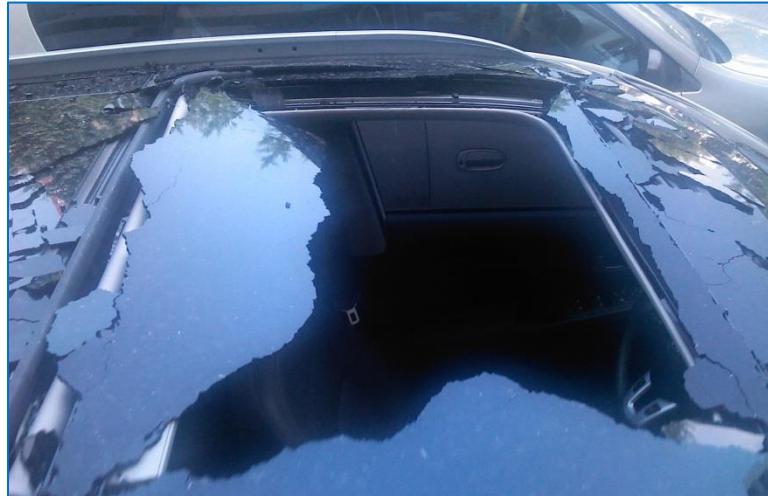
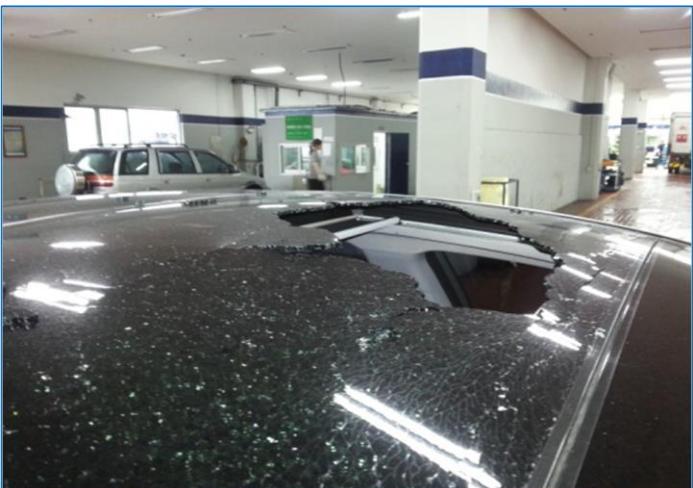
### Images of panoramic sunroof damages

- ◆ The use of panoramic sunroofs has been increasing since 2007
- ◆ The ceramic print area was small in conventional sunroofs, but, with the introduction of panoramic sunroofs the ceramic print area has increased
  - Ceramic print area of panoramic sunroofs is **50% on average**, and **90% maximum**.
- ◆ Black enamel, the paint used for ceramic print area of automobile toughened glass, is **produced by 2 companies** and is distributed throughout the world
  - Components of black enamel thought to be adulterant in toughened glass – impairs sunroof strength
